# Manhole Inspection Summary

Manhole # S09QQ1012MH

Insp Date: **1/21/09 11:54 AM**

**Location** Address: **5121 QUEENSBURY AVE REAR ALLEY** Cross Street: **BELVEDERE-SPAULDING ALLEY**

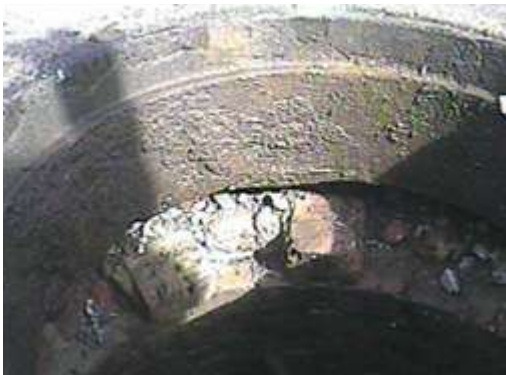
Defect 2

**Chimney / Frame Adjustment** ☒ Exists Material: **Brick** ☐ Parged Height: **2** (in.)  
Condition: ☐ Sound ☐ Cracked ☐ Root Intrusion ☒ **Loose Brick** ☐ Deteriorated  
Infiltration: ☒ None ☐ Joint ☐ Cracks ☐ Mortar ☐ Roots ☐ Wall

FRAME ADJUSTMENT- LOOSE BRICKS

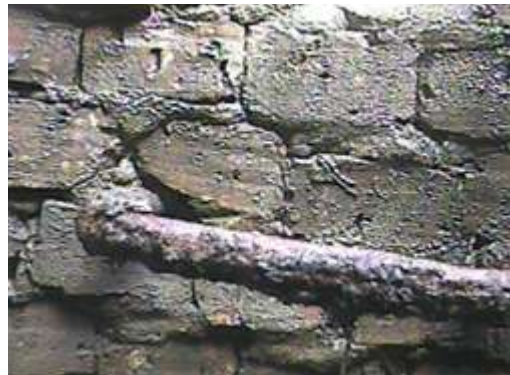
Defect 1

**Steps** Count: **2** Missing: **0** ☒ **Corroded**

CORRODED TOP RUNG

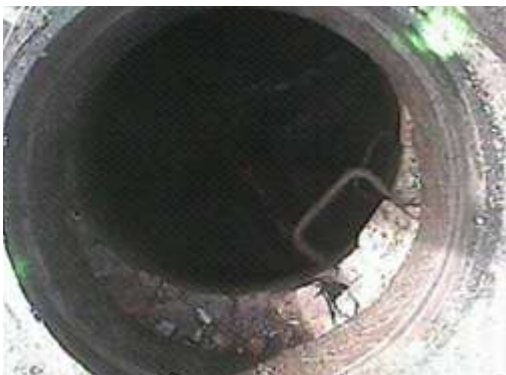
Defect 3

**Frame** Offset: **3.** (in.) Condition: ☒ Sound ☐ Cracked ☐ Leaks  
**25**

FRAME OFFSET

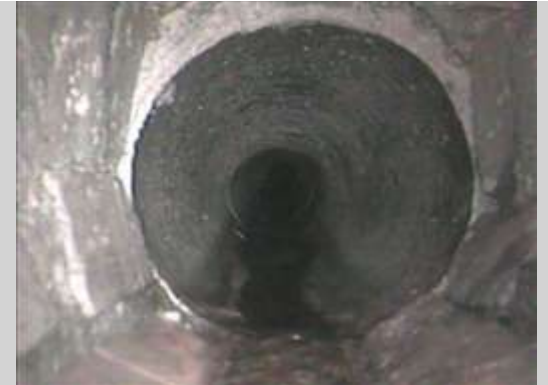
12 O'Clock Outflow

10 in. Circular Gravity Sewer  
Pipe Out @ 12 O'Clock

Pipe Height: (in.) Direct  
Pipe Material: **Clay** ☐ Pipe Lined  
Invert Depth: **6.79** (ft.) Flow Characteristics: **Slow**  
Deposits: ☒ None ☐ Mud ☐ Sludge ☐ Debris ☐ Grease  
Silt Depth: (in.) Deposits Extent:  
Infiltration: **None** Pipe Seal Cond: **Sound**

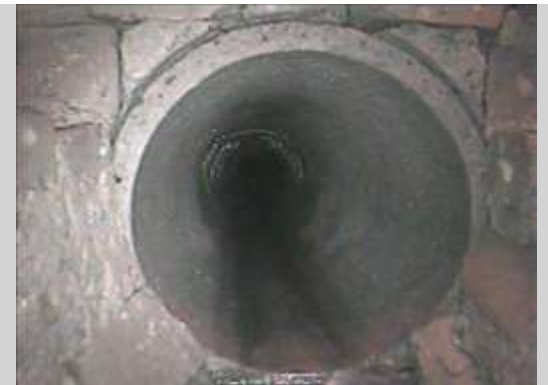
3 O'Clock Inflow

10 in. Circular Gravity Sewer  
Pipe In @ 3 O'Clock

Pipe Height: (in.) Direct  
Pipe Material: **Clay** ☐ Pipe Lined  
Invert Depth: **6.38** (ft.) Flow Characteristics: **Slow**  
Deposits: ☒ None ☐ Mud ☐ Sludge ☐ Debris ☐ Grease  
Silt Depth: (in.) Deposits Extent:  
Infiltration: **None** Pipe Seal Cond: **Sound**

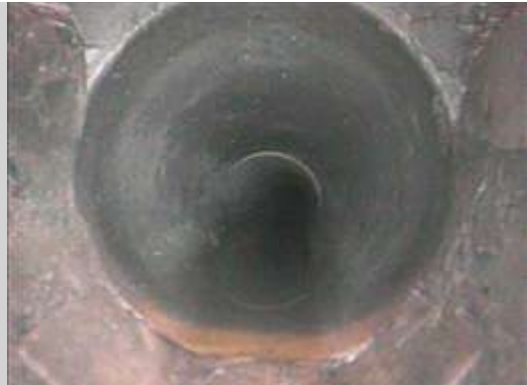
6 O'Clock Inflow

Pipe Height: (in.) Direct

Pipe Material: **Clay** ☐ Pipe Lined

Invert Depth: **6.61** (ft.) Flow Characteristics: **Slow**

Infiltration: **None** Pipe Seal Cond: **Sound**

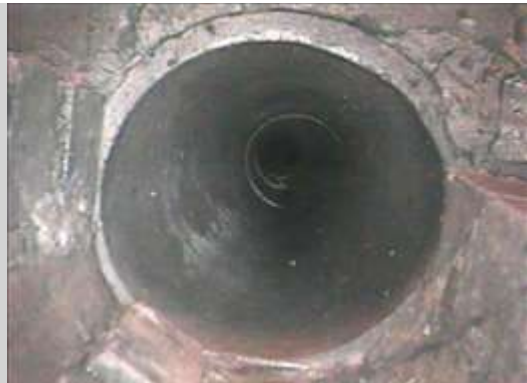
9 O'Clock Inflow

Pipe Height: (in.) Direct

Pipe Material: **Clay** ☐ Pipe Lined

Invert Depth: **6.55** (ft.) Flow Characteristics: **Slow**

Infiltration: **None** Pipe Seal Cond: **Sound**
